## **Update on the Non-Emergency Breach at the Columbia Lock and Dam**

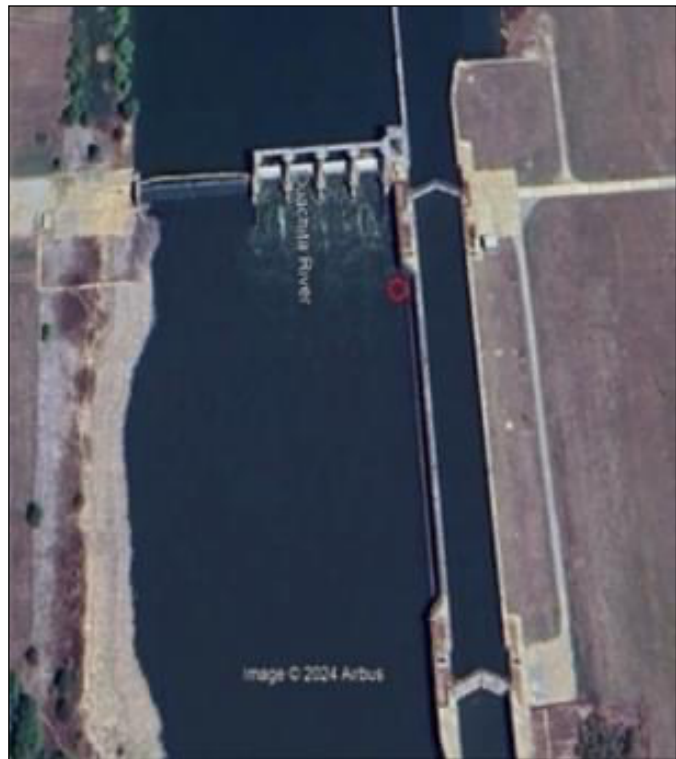
An aerial photo of the Columbia Lock and Dam indicating the location of the non-emergency breach.

Rock placement at Columbia Lock and Dam was completed on November 3, 2024. This placement includes the gravel added to the voids as well as the heavier rip-rap that was placed along the lock wall to create a seepage berm.
